## Minerals Inspection Report

Mine Name: Kingston Canyon Rock	Permit Number: <i>S/031/0009</i>	Mine Status: Reclaimed
Operator Name: Utah Div. Wildlife Res. / Stan Beckstrom	Inspection Date: 5/27/2015	Permit Fees: No Fee Req.
Inspector(s): Lynn Kunzler	Inspection Time: 3:00 pm	Bond Amount: \$0
Attendee(s):	Weather:	Bond Escalation:
Inspection Purpose: Routine inspection		Prior Inspection: 6/19/2013

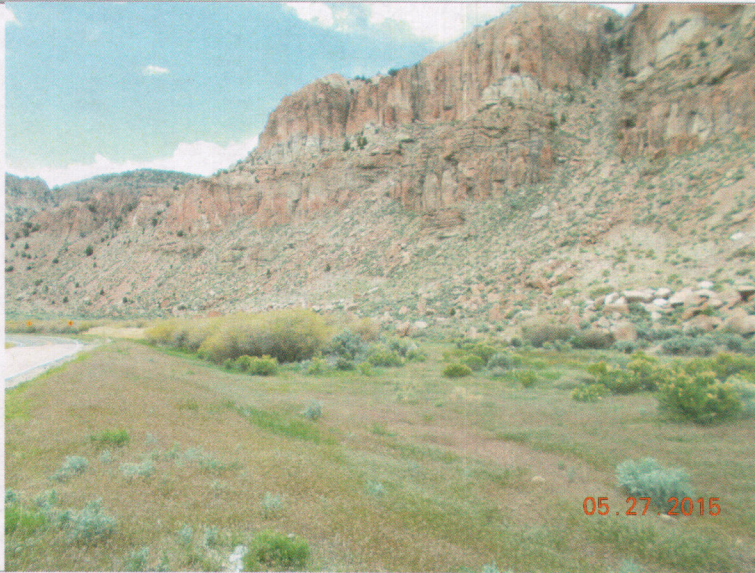
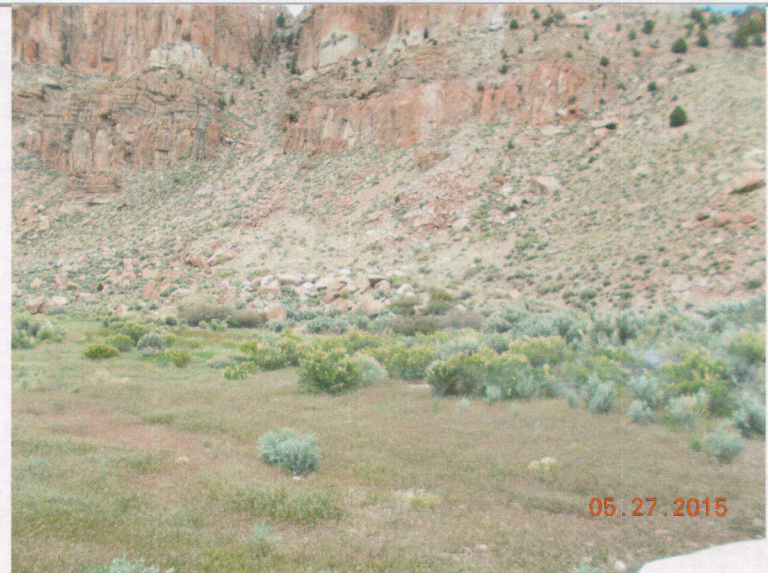
Inspected: 5/27/2015

6. <i>Reclamation</i> The site was reclaimed prior to the June 19, 2012 inspection. Vegetation has re-established and is about 90% of the surrounding vegetation ground cover.	<input checked="" type="checkbox"/>	<input type="checkbox"/>

9. <i>Revegetation</i> The site is well vegetated with desirable species (no noxious weeds). Vegetation ground cover exceeds the 70% of pre-existing cover success standard.	<input checked="" type="checkbox"/>	<input type="checkbox"/>
